The NIST WTC Investigation-- How Real Was The Simulation?

A review of NIST NCSTAR 1

By Eric Douglas, R.A.

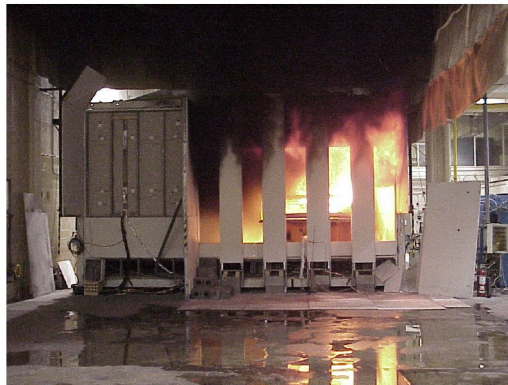
Figure 4-6. Multiple workstation fire experiment.

A fundamental problem with these tests, however, is that, as NIST’s Figure 4-6 (NCSTAR 1-5 p77 and below) shows, the tests were not ventilation limited. The fires in the WTC buildings were.

Two other things that are important to keep in mind regarding the temperatures of these tests are the length of time to peak temperature and the heat transfer rate to the structural steel. NIST’s tests found that peak temperatures were reached in 20-30 minutes, and that temperatures were below 600C shortly thereafter. (NCSTAR 1-5 p78 Figure 4-8). Later, in NCSTAR 1-6, NIST states that “results of both the multi-workstation experiments and the simulations of the WTC fires showed that the combustibles in a given location, if undisturbed by the aircraft impact, would have been almost fully burned out in about 20 min.” (p280, para1) Therefore, based upon these tests, the fires had only about 20 minutes to affect the temperature of any exposed steel structure (these tests measured ambient air temperature, not the temperature of the steel). Since NIST states repeatedly that insulated steel would not have failed, we are left to consider whether the rubbleized debris left in the wake of the aircraft trajectory, with its arguably greatly reduced surface area, would have burned longer than the workstation tests, and whether this time would have been sufficient to transfer enough heat to insulation-compromised steel members. The most critical fires would have started first. (The critical area was where insulation might have been compromised by aircraft impact. This is also where the fires would have originated.) Therefore, if they were at all similar to fires in the multiple workstation tests, they should have done their damage within the first half hour—long before either tower 1 or 2 fell.

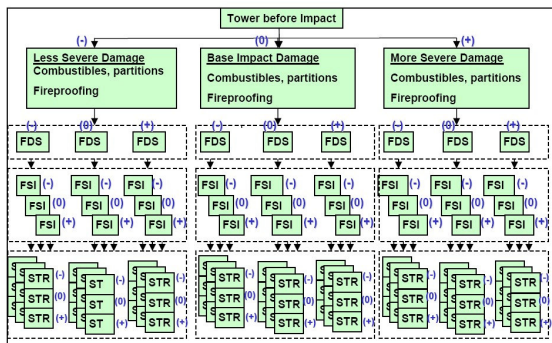
Figure 9-2. Full analysis tree for influential parameter effects.

Looking at NIST’s Figure 9-2 in NCSTAR 1-6 page 291, one gets the idea that NIST ran three variants each (less severe, base, and more severe) of four tests, for a total of 81 scenarios. Thus, we are puzzled when we go searching for the “less severe” case for the second and third tests. The second test is the Fire Dynamics Simulator (FDS). NIST has this to say about why a less severe case for the FDS can not be found:
